HSE BULLETIN

Failure of Fall Arrest Equipment – SpanSet 30kN Karabiner

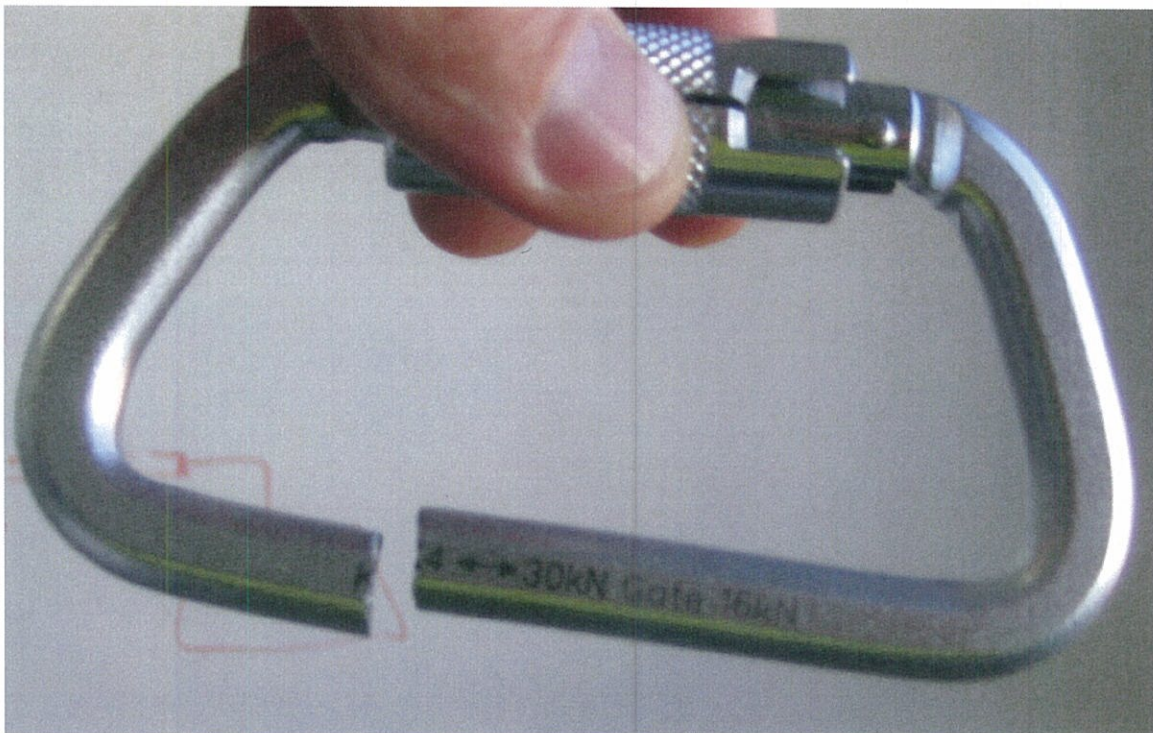
A karabiner rated to a SWL of 30kN and manufactured by SpanSet catastrophically failed under a minimal load of approximately 150kg on the Yarwun 2 Project on Tuesday 20 July 2010.

The karabiner was one of a batch of 60 recently purchased and first used on 9 July 2010. It was attached between a beam strap and a synthetic static line rated for one person under normal tensioning conditions. The failure was noted during an inspection of the static line assembly prior to use.

All karabiners supplied with the recent order from SpanSet have been quarantined pending investigation. The Division of Workplace Health and Safety and the manufacturer have been notified of the failure.

This equipment failure highlights the importance of inspecting all equipment and PPE before use and at the prescribed 3 monthly intervals. An inspection of all rigging and lifting equipment is to be conducted immediately. Where team members suspect any damage to or deterioration of equipment, whether it be mechanical or caused by environmental factors, tag the equipment with an "Out of Service" tag and advise your supervisor who will arrange an inspection by a competent person.
